# Analysis of an encrypted HDD

J. Czarny, R. Rigo

The idea of this presentation is to debunk the myth that analyzing the security of hardware is difficult. From the perspective of a software reverse engineer we present the process of studying a hardware-encrypted, PIN secured, external hard drive: the Zalman VE-400.

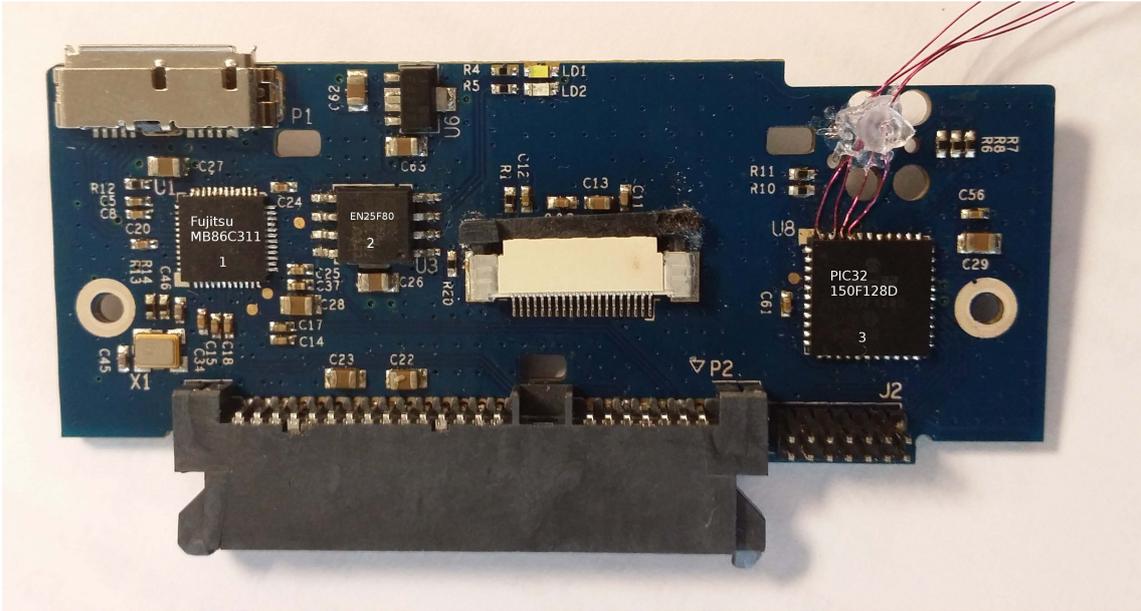
Figure 1: PCB front side

- one Fujitsu MB86C311A USB3-SATA controller (1 on figure 1)
- one PIC32MX150F128D MIPS microcontroller (3 on figure 1)

- two EEPROM SPI EN25F80-100HCP flash (2 on figure 1, 4 on figure 2)

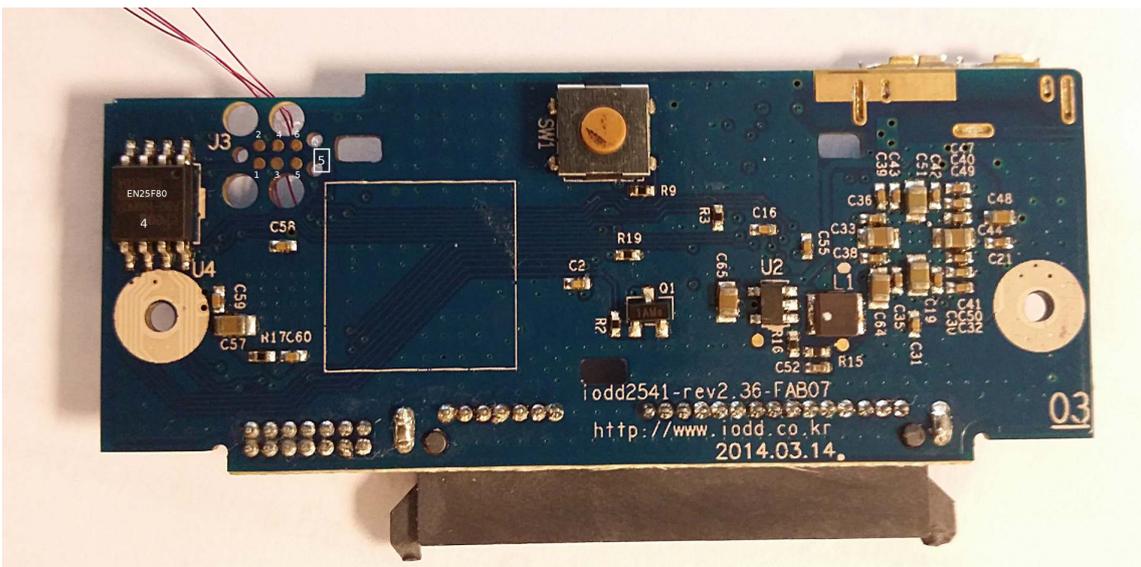
Figure 2: PCB back side

Trace analysis showed that the J3 6-pads header on the back (figure 2) is connected to pins that are used for ICSP access.

As show on the figure 2, the pad/test point<sup>6</sup> for J3 header are big enough to solder wires.

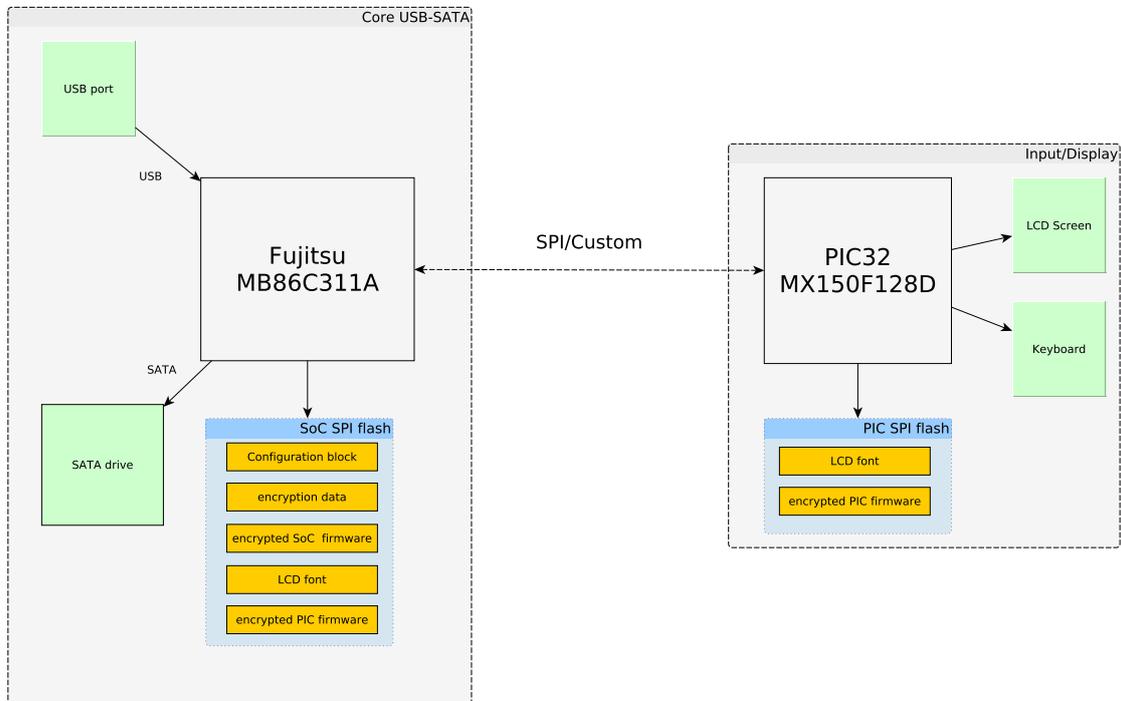
Figure 3: Schematic view of the various components

- the PIC is connected to the keypad using pins 19, 20 and 23 to 27
- the flash on the back is connected to the PIC
- the flash near the Fujitsu is connected to the SPI pins of the SoC
- the PIC is connected to the Fujitsu’s GPIOs by PINs 9,10,42,43,44
- the PIC is connected to the LCD screen
- the PIC is connected to the J3 6-pads connector on the back side

It should come as no surprise that the PIC is responsible for handling display and input. Of course, it must exchange information with the SoC, hence the connections. Both flash chips are probably used for firmware and/or settings storage. While the PIC has an internal flash, its size may not be sufficient.

Now that we know the different components, as summarized on figure 3, we would like to dump the code from the PIC and Fujitsu controllers to complete our understanding.

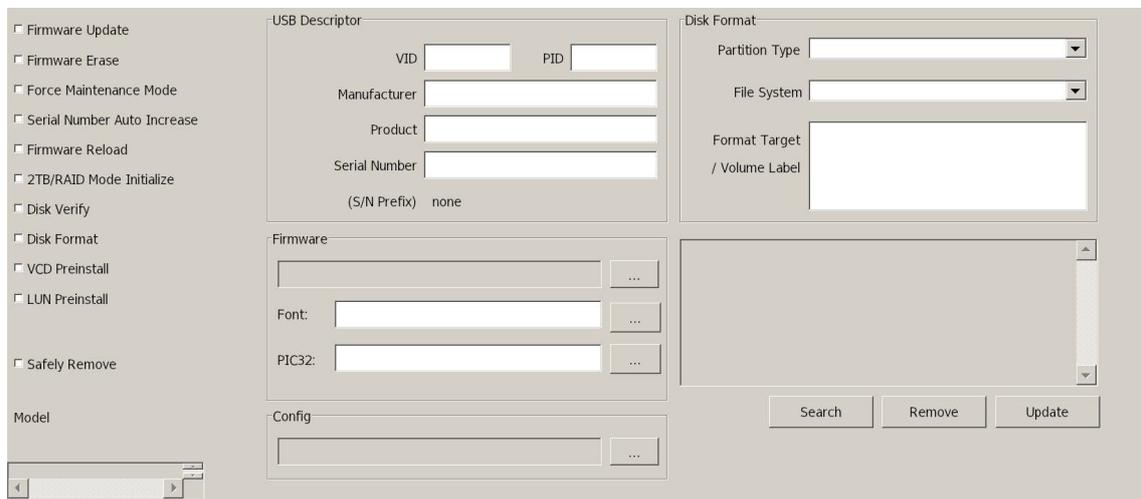
Figure 5: Firmware updater settings dialog extracted from resources

Just looking at the dialog boxes contained in the resources section is interesting, figure 5 shows that “micom” file most probably is used in the PIC32 field. Which validates our initial hypothesis.

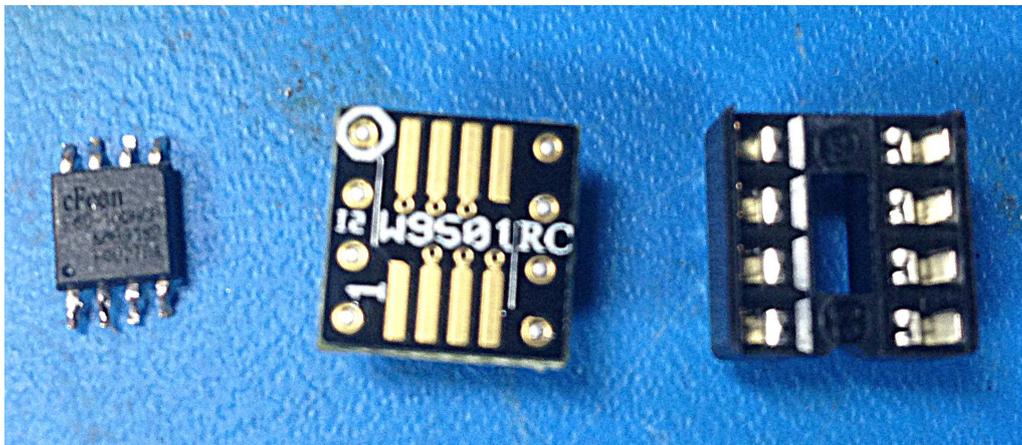
Figure 6: Unsoldered flash

Unfortunately, dumping SPI flashes directly from the board using a SOIC clip is usually hard, as the current will also power surrounding chips that will interfere. So, unsoldering is needed. However, it is interesting to re-solder the flash on a SOIC to DIP connector in order to keep the board fonctionnal and useful for subsequent analysis (see figure 6).

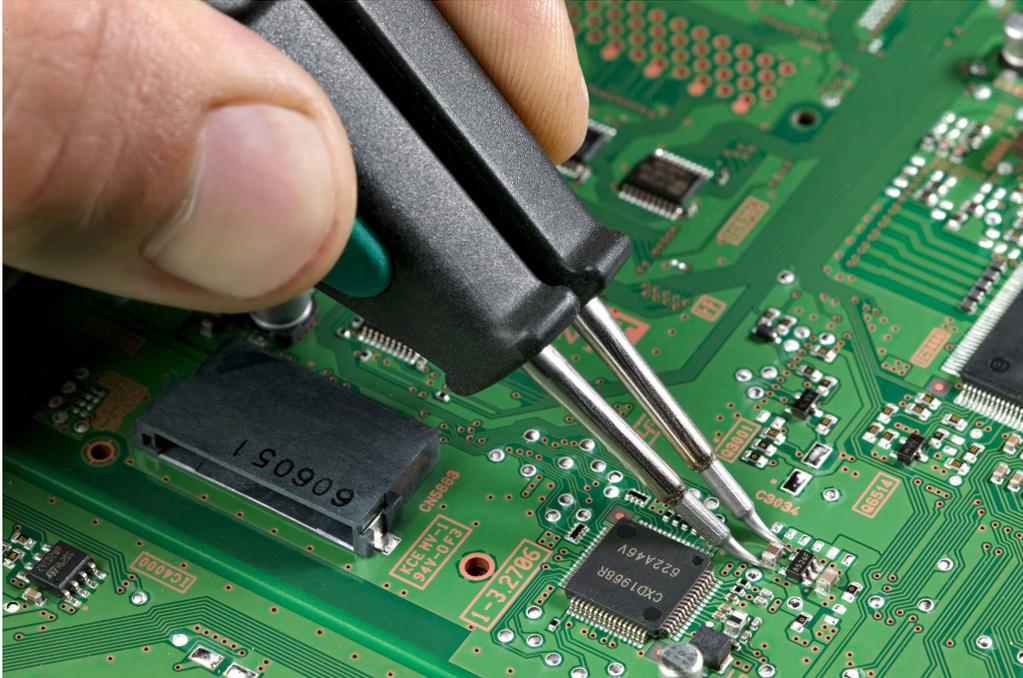
Figure 7: Tweezers soldering iron / Credit : Aisart on Wikipedia (CC-BY-SA 3.0)

Another mistake often made is unsoldering pins one by one by using something to raise the pin. But it frequently leads to broken pins or to traces disconnected from the PCB. A good solution is to use tweezers soldering iron, as on figure 7.

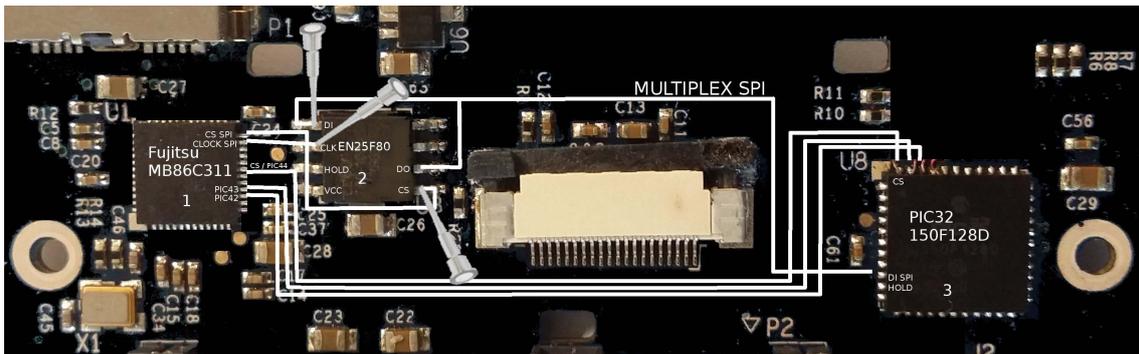
Figure 8: Physical traces and probes placement

Since section 3.2 we have a good idea of which pins are used for communication between the SoCs and for flash access. Some are used for both, which is quite handy because the logic probes are small enough to be directly attached to the SPI pins. Figure 8 shows the important traces and where the probes have been connected: *Chip Select*, *Clock*, and *DI/DO* pins.

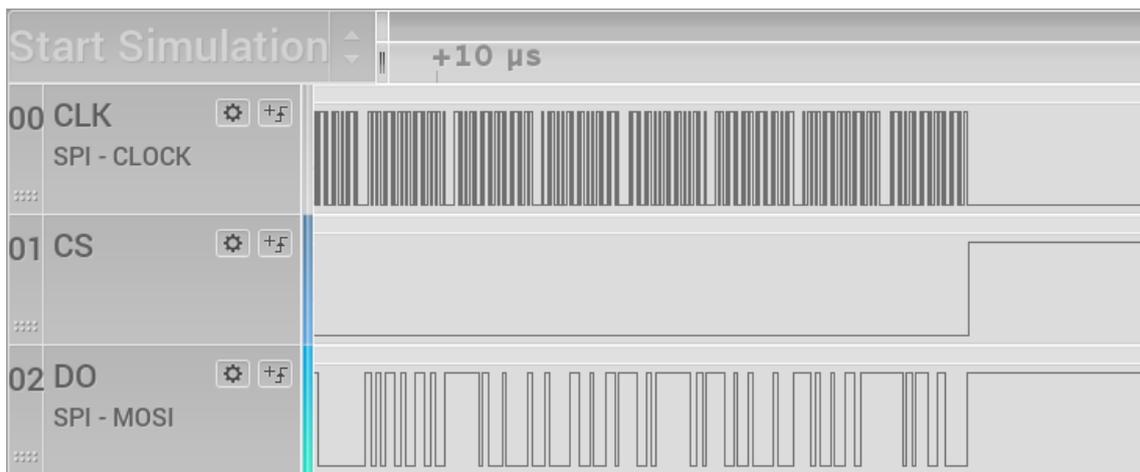
Figure 11: Logic analyzer results

Figure 11 shows the result in the analyzer window.

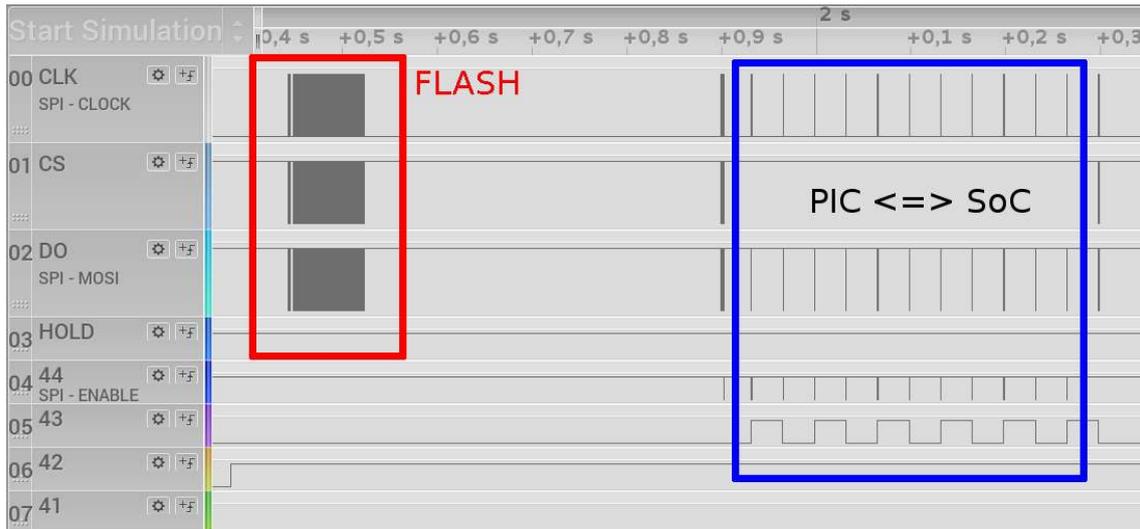
Figure 12: Trace of both flash and PIC↔SoC communications

Figure 12 shows a trace with both communications. The red block, on the left, clearly contains communications from the SoC to the flash as the CS pin is brought low (not visible here) for each transfer. While the blue block, on the right, is different: the CS pin is maintained high while the pins CLK, DO, 44 and 43 are active.

- CLK (named from the SPI flash pin) is obviously also a clock
- DO is also used for data transfer
- pin 44 is used as a CS for the PIC
- pin 43 is used as a “broader” CS, as seen on figure 12

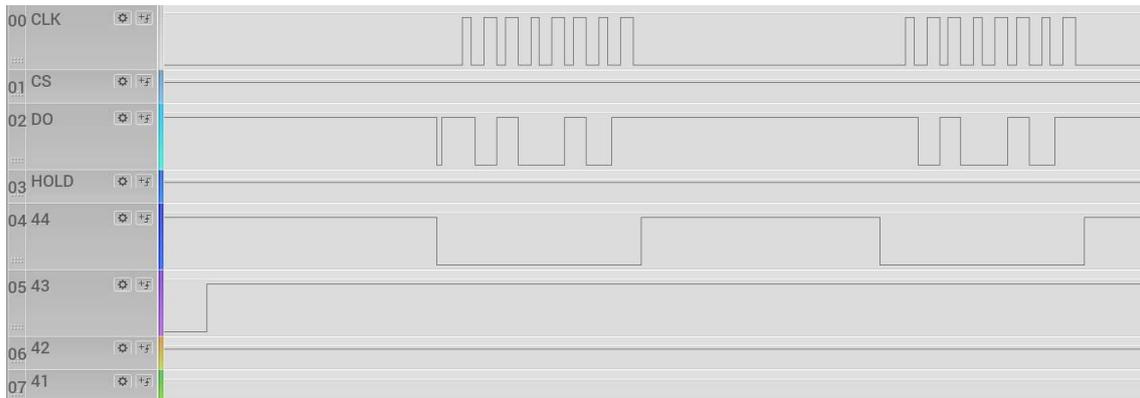
Figure 13: Detail of PIC↔SoC communications

Figure 13 shows the beginning of the blue block in details. Analysis is rather straightforward:
