Ghost in the Wireless, iwlwifi edition

Nicolas Iooss and Gabriel Campana
nicolas.iooss@ledger.fr
gabriel.campana@ledger.fr

Abstract. Wi-Fi replaced Ethernet and became the main network protocol on laptops for the last few years. Software implementations of the Wi-Fi protocol naturally became the targets of attackers, and vulnerabilities found in Wi-Fi drivers were exploited to gain control of the OS, remotely and without any user interaction. However, not much research has been published on Wi-Fi firmware, outside of Broadcom models. This article presents the internals of an Intel Wi-Fi chip. This study, mostly conducted through reverse engineering, led to the discovery of vulnerabilities such as arbitrary code execution on the chip and secure boot bypass, which were reported to the manufacturer.

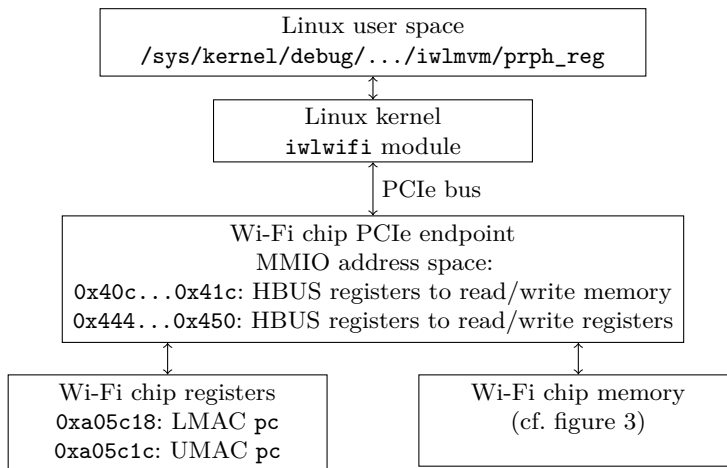
implementation seems to be directly in hardware (it does not involve the firmware). This impression is strengthened by the fact that this interface can be used to read the program counters of the chip processors. Doing so shows values which change so much that this indicates that neither the UMAC or the LMAC processor is executing code to process host requests to read peripheral register values. This interface is described in figure 4.

`iwlwifi` also defines offsets (macros `HBUS_TARG_MEM_RADDR`, `HBUS_TARG_MEM_RDAT`, etc.) and functions (`iwl_trans_pcie_read_mem` and `iwl_trans_pcie_write_mem`) to access the chip memory. Of course these functions cannot be used to write to arbitrary memory locations at runtime but their use by functions such as `iwl_trans_pcie_txq_enable` indicates that some regions of the firmware are indeed writable from Linux.

Fig. 4. Interaction between Linux debug filesystem and the Wi-Fi chip

Nevertheless, `iwlvm/mem` in the debug filesystem does not use this interface. Instead the implementation of the read operation (in function `iwl_dbgfs_mem_read`¹⁹) boils down to calling `iwl_mvm_send_cmd(mvm, &hcmd)`; with a *host command* in the parameter `hcmd`. This function calls `iwl_trans_pcie_send_hcmd` to enqueue a command in queues that the Wi-Fi chip reads using Direct Memory Access (DMA). This interface is shared with every command that the Linux kernel sends to the chip
